CMOM ANNUAL REPORT CY2018

Capacity, Management, Operations and Maintenance (CMOM) Plan Overview

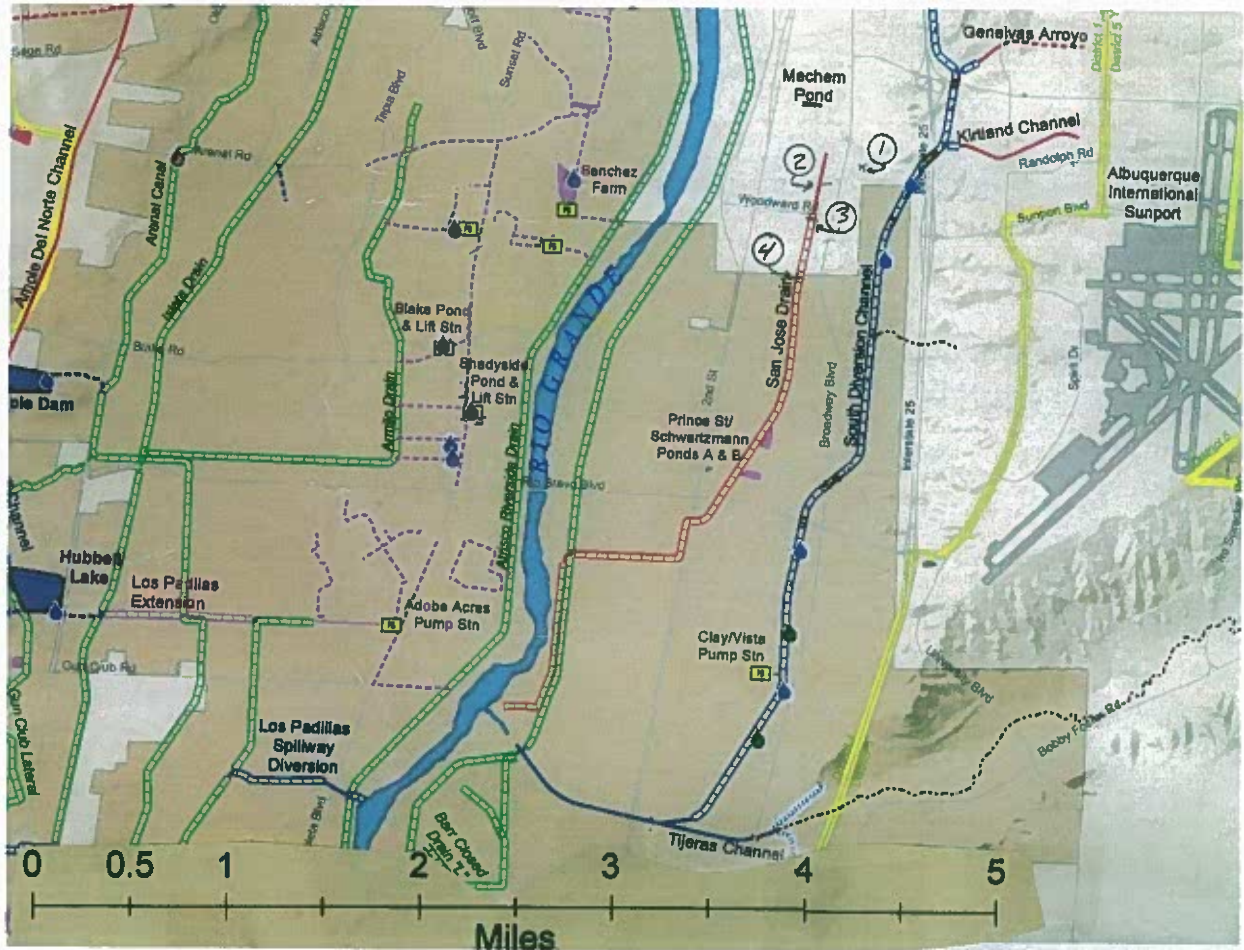
Location Sketch

The subject SSO was caused by a structural collapse of the pipe between manholes M14-971 and N14-061. Due to topography, i.e., the lowest upstream manhole ring and cover, the spill discharged from manholes M14-473 and -474. This report addresses:

The line segment from M14-971 to N14-061 had been found to be severely corroded and a construction project was underway to rehabilitate the line under Project No. 849.023 but the line collapsed before the rehabilitation could be completed. This location is severely restricted in terms of digging up a collapsed line. There are two railroad spurs, one used daily, two fuel pipe lines, one natural gas line, and an overhead electric line with pole adjacent to the collapse. Between the daily train-induced vibrations and the non-cohesive blow sand, the excavations were very unstable and repeatedly collapsed. Flow was maintained as much as possible by excavating as much as possible given the site restrictions. Due to the continuing and progressive nature of the collapses, the spills are considered the result of one blockage. In parallel to flow maintenance by excavation, a by-pass pumping system is being installed. The first pump and force main is now in place and additional are being installed.
