EMERGENCY PURCHASE REPORT

College Arsenic Treatment Facility (ATF) has a 30,000-gallon raw water storage tank located upstream of the ATF. This steel storage tank is part of the ATF and is feeding raw groundwater to the plant.

Re: **College Backwash Reservoir D&R Tank Serial # 06-60601**

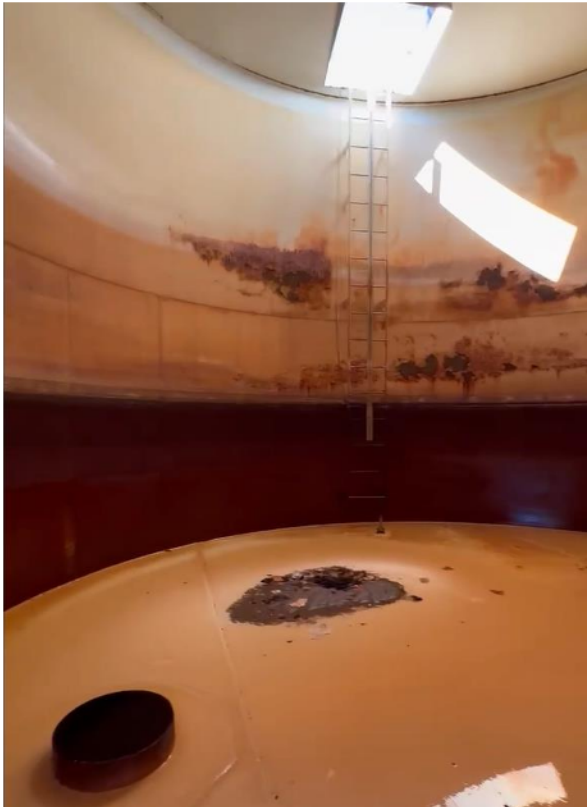
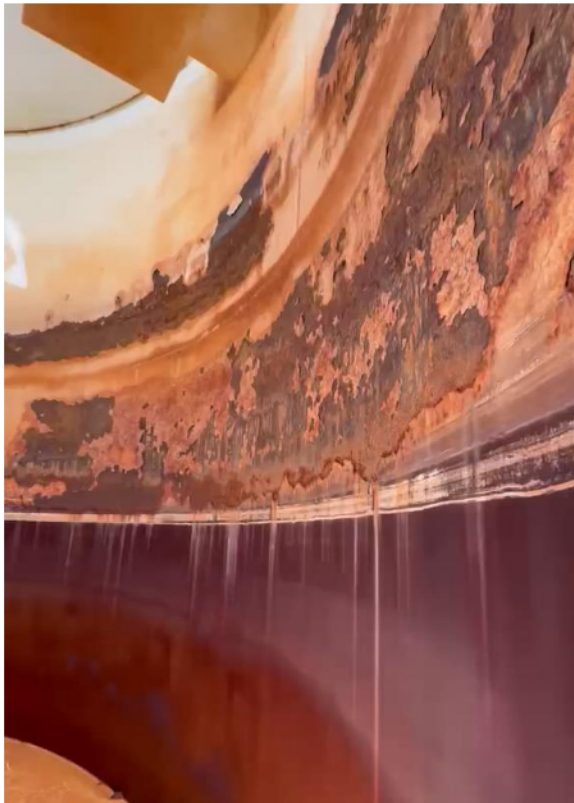
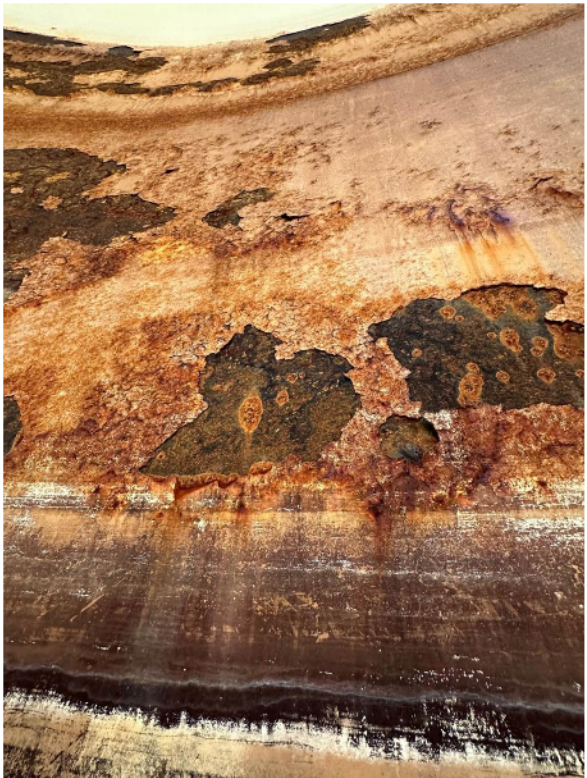
The SJC Plant Operations group first encountered plant alarms on September 28, 2024. The ATF membranes were fouling and causing the plant to shut down due to excessive differential pressures. The Plant Operations and Groundwater Operations groups checked the feed wells and upstream pump station, but no sand or water quality issues were observed. The College ATF on-site storage tank was emptied, and a dry inspection was performed by Operations on October 2, 2024. It was determined that the coating inside the tank has completely failed. Debris accumulation was observed inside the tank. Photos from the dry inspection are included below.

The debris and rust chipping off from the tank were entering the ATF and causing excessive fouling of the membranes. The Operations took the College ATF off-line on October 2, 2024 to protect the membranes and prevent complete failure of this asset. A second dry inspection was performed by Operations and D&R Tank on October 3, 2024 at 11:30am. Repairs to the storage tank are needed before the College ATF can be put back on line.

All labor, materials, and supervision to field paint and chlorinate one 30,000-gallon welded steel water storage tank, including:

- Record drawings
- Interior and exterior painting system
- Sika Flex interior roof
- Independent NACE inspection
- Disinfection of tank upon completion of work
- One year warranty including 11-month inspection with tank empty and out of service
