CMOM Annual Report 2023

Capacity, Management, Operations and Maintenance (CMOM) Plan Overview

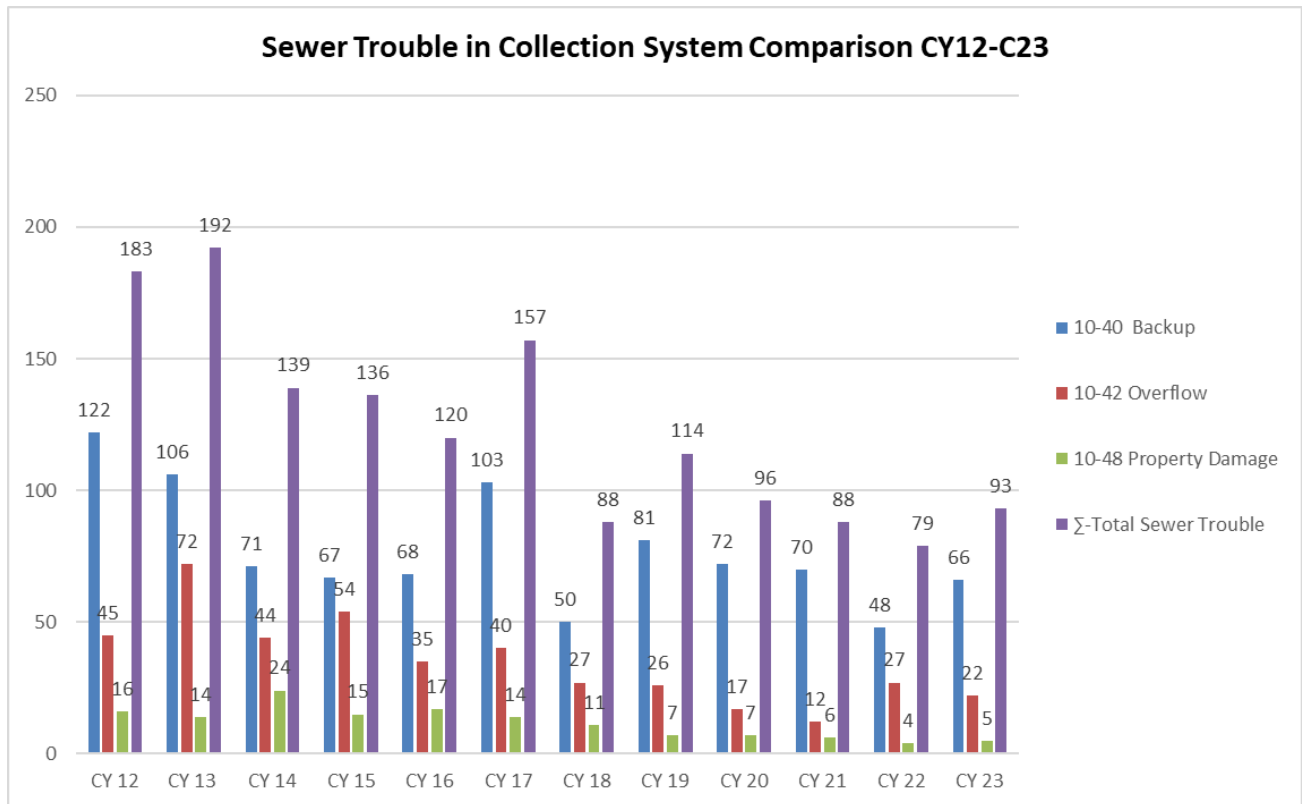
Figure 2 Sewer Trouble Comparison

Figure 2 shows the total sewer troubles, i.e., 10-40s, -42s, and -48s by year for CY2012-23.

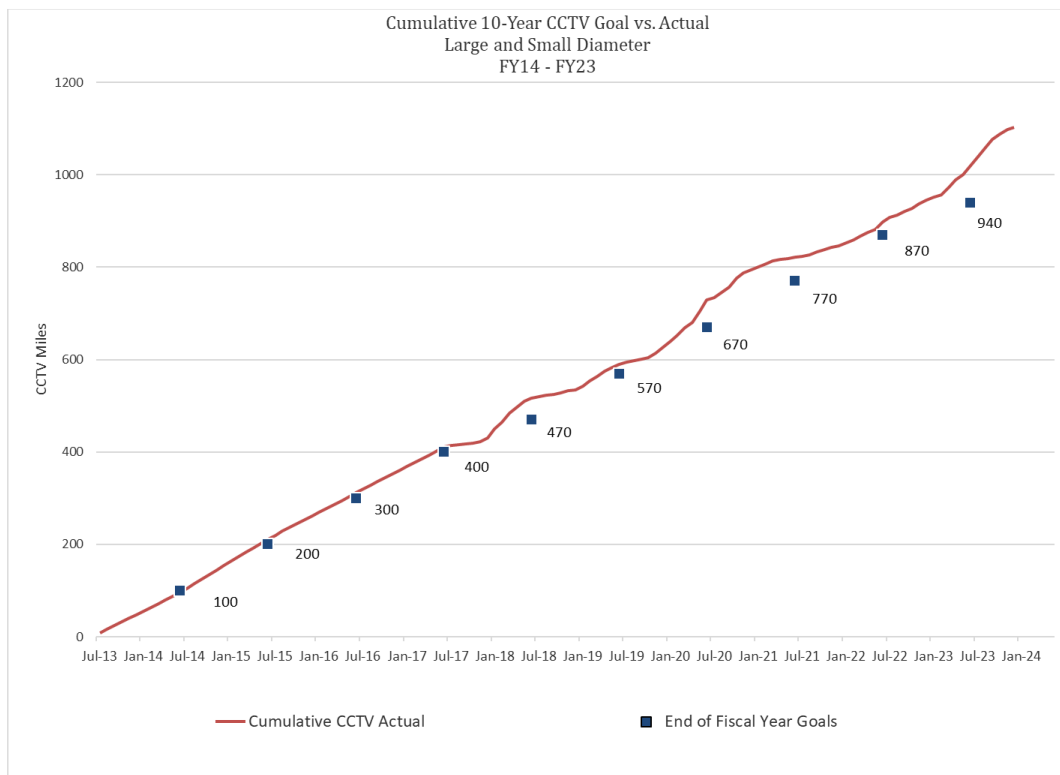
Figure 3 Small & Large Diameter Sewer CCTVed vs. Ten-Year Goal

CMOM Report figures for cleaning and CCTV will continue showing fiscal year (FY) goals in accordance with funding and contracting cycles and actual metrics will reflect work through the end of the calendar year (CY). Figure 3 provides the CCTV goal for a ten-year basis and the actual CCTV inspection through CY2023. The CY2023 portion of this recommendation is complete. The CCTV program will continue. Anticipated schedule:

1. FY24: 5% of the small diameter.
2. FY25: 5% of the small diameter.
3. FY26: 5% of the small diameter.
4. FY27: 5% of the small diameter.
5. FY28: Large diameter unlined concrete pipe.

This is an on-going program. The following recommendation is made in the FY2013 CMOM Report: “CCTV inspections of the collection system as follows: 1) Small diameter main lines less than 15” : In four of five years, televise approximately 5% per year of the small diameter system. Televise high risk lines based on current Asset Management Plan and subsequent in-house analysis. 2) Large diameter lines 15” and larger: Every fifth year, televise as much as possible acknowledging access limitations of the unlined concrete lines 15” and larger. Anticipated schedule: 3) FY2014-17: 5% of the small diameter each year. 2) FY18: Large diameter unlined concrete pipe.”

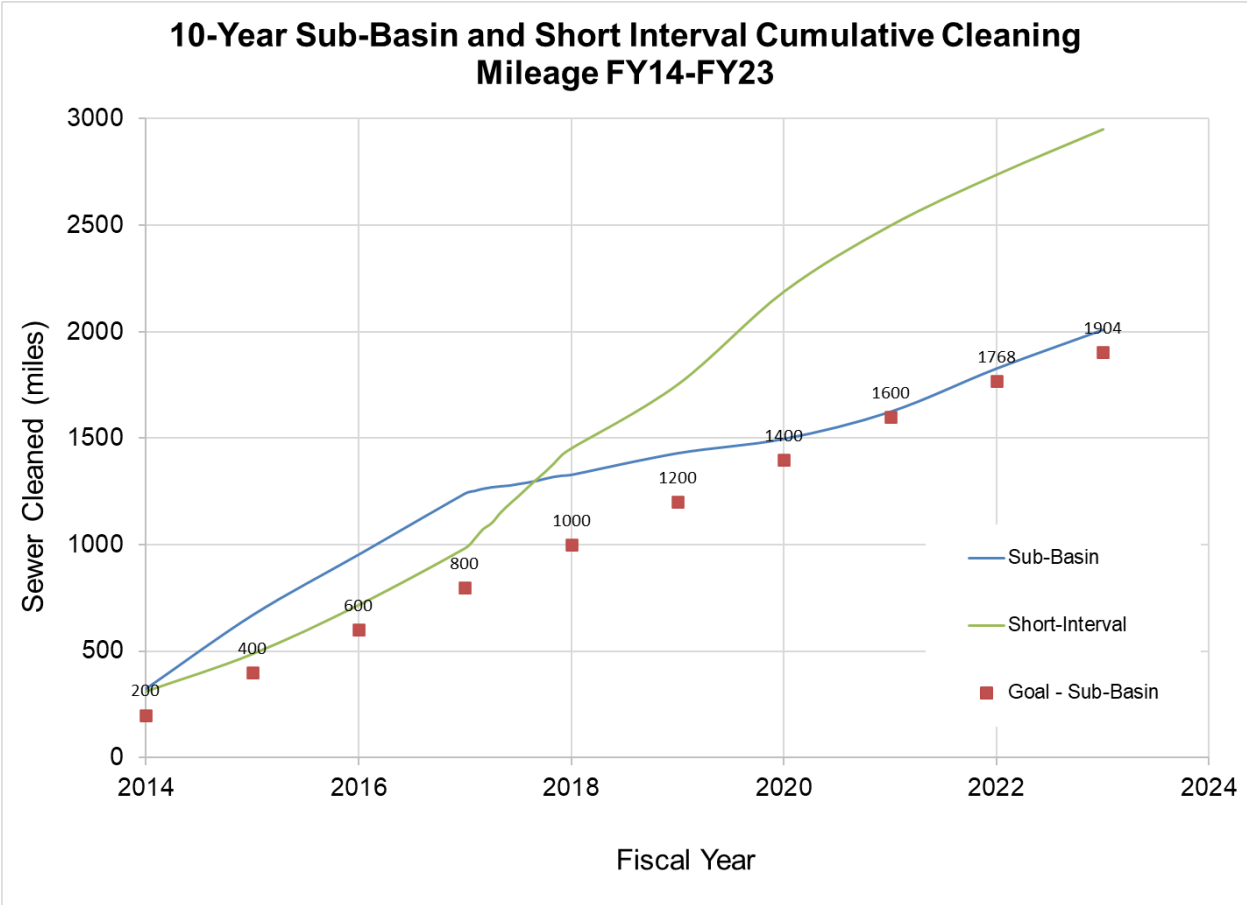
Figure 4 Small Diameter Sewer Cleaned vs. Ten-Year Goal

Figure 4 shows the actual cleaning performed by fiscal year. The modified Sub-Basin goals are shown starting with CY 2022.

The following recommendation is made in the FY2013 CMOM Report: “The Water Authority will establish and monitor a goal of cleaning all gravity small diameter lines every ten years. (This will be accomplished through the existing Sub-Basin program.) The Water Authority will continue the program of high-frequency maintenance of known problem locations within the system. (This will be accomplished through the existing Short Interval program.) The frequency of Short Interval cleaning will vary in accordance with system performance and risk factors, maintenance history, and the latest maintenance findings.”
